Mandena Mine Salinity Control Weir

MANDENA MINE SALINITY CONTROL WEIR, MADAGASCAR

WINNER - International Projects category

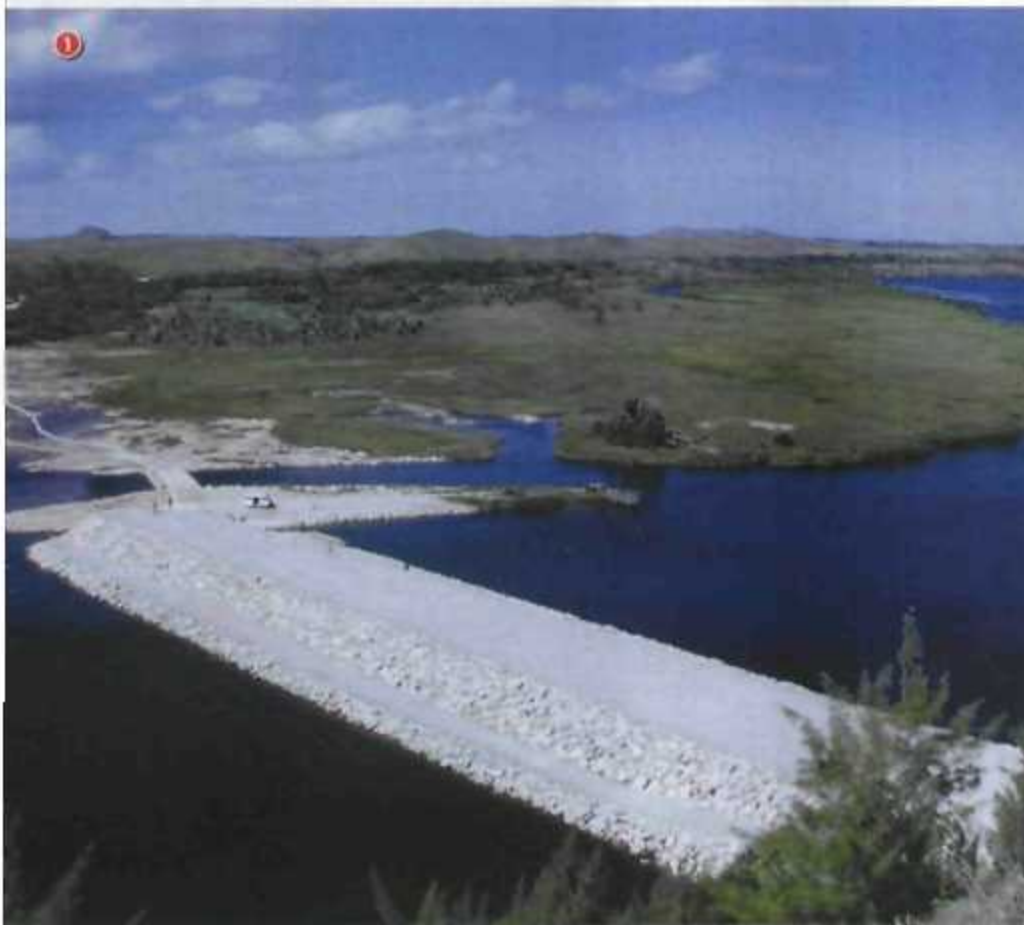
1 The completed Mandena salinity control weir and low flow spillway, Madagascar

With a 300 m long spillway with a crest level of RL 1,1 m, the increase in flood levels as a result of the weir ranged from 0,76 m at the structure itself, to 0,28 m at the nearest human settlement, which is considered to be acceptable.

A low flow spillway with a capacity of around 20 m³/s was provided to carry the normal river flow. This spillway is equipped with flap gates to prevent reverse flow when the downstream water level is higher than the upstream level.

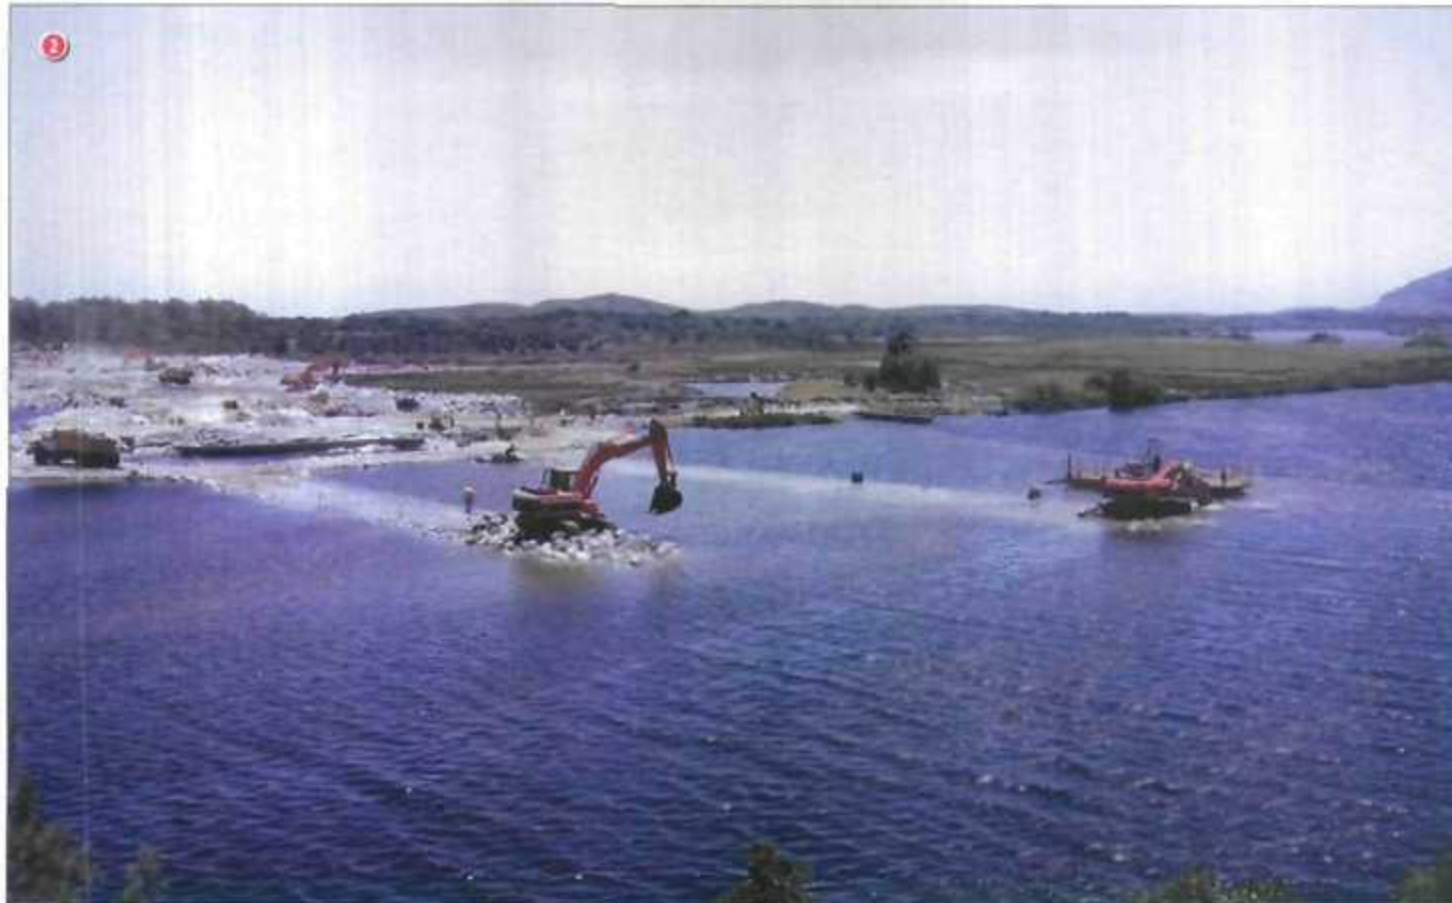
2 Construction of the two initial embankments

The basic concept for the salinity barrier, to be erected just downstream of Lake Ambavarano, was a wide spillway on the left bank, excavated in a rocky outcrop, and a rockfill weir embankment across the Anony River, constructed using the material excavated for the spillway. At this point overall width of the river is about 120 m with a maximum water depth of 4 m. The wide spillway would allow for the passage of floods.

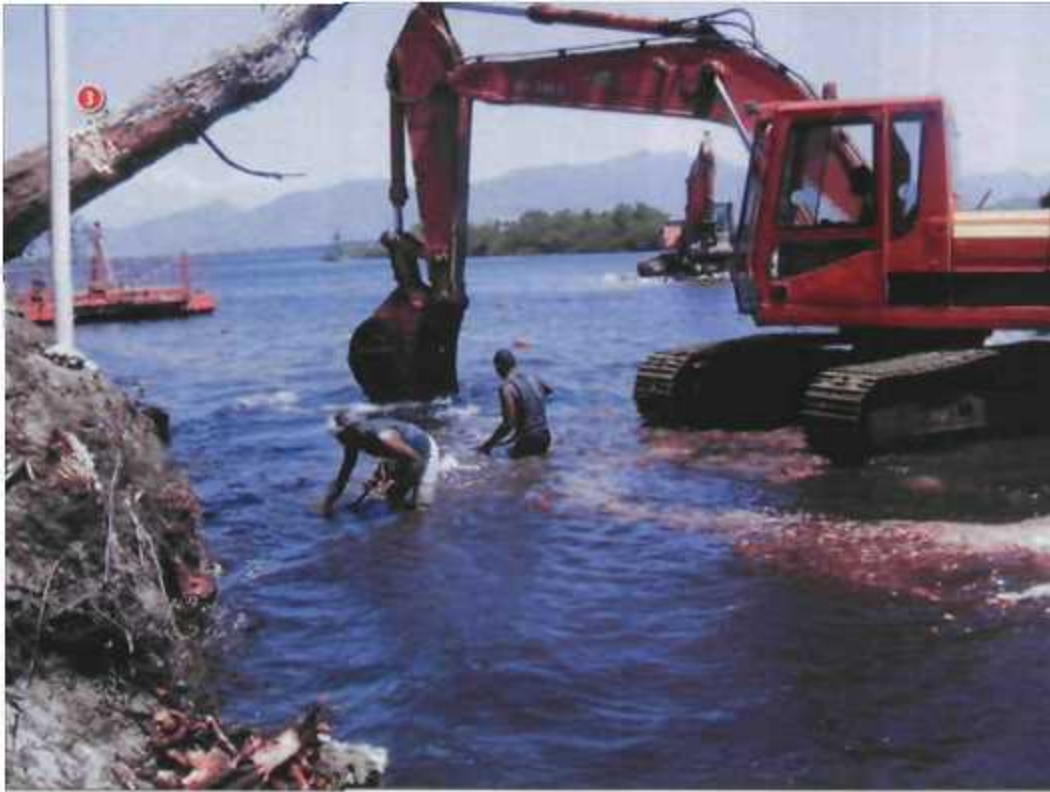
- 3 Closing the rockfill embankment against the right bank sand dune
- 4 Laying geotextile underwater during the construction of the weir
- 5 The low flow spillway with balanced gates

Closure of the embankment against the right bank

To limit damage from river flows to the right bank, just prior to closing the embankment, the contractor artificially closed the estuary mouth with sandfill. This effectively prevented all river and tidal flows from entering the river and allowed the embankment to be carefully completed against the right bank.
